Wall & Ceiling

One King West

by Don Procter

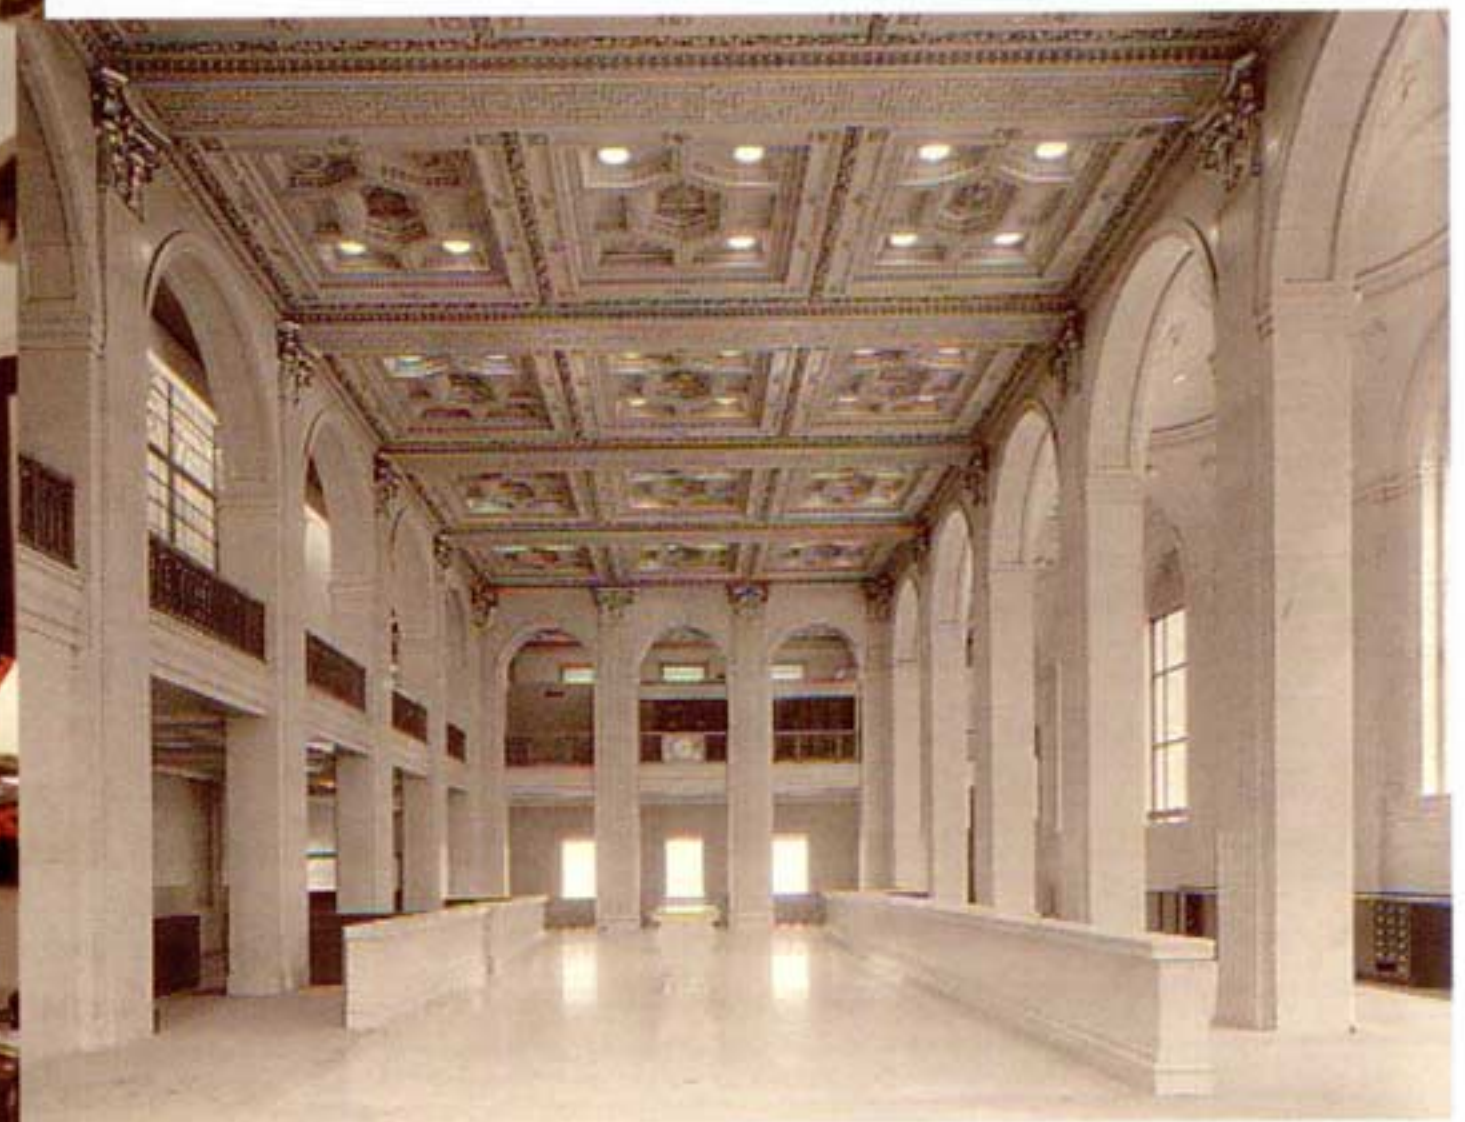
A number of techniques are used to restore the plaster, says Furieri. Pinning is one method of stabilizing existing delaminated plaster. This involves reinforcing around the perimeter of the cracked and delaminated plaster by drilling

on angle 1/4-inch holes and injecting them with a PVA modified gypsum plaster. The PVA plaster fills voids in delaminated areas, bonds the two plaster coats and creates a key or lock on the lath side. Screws are countersunk to strengthen the bond.

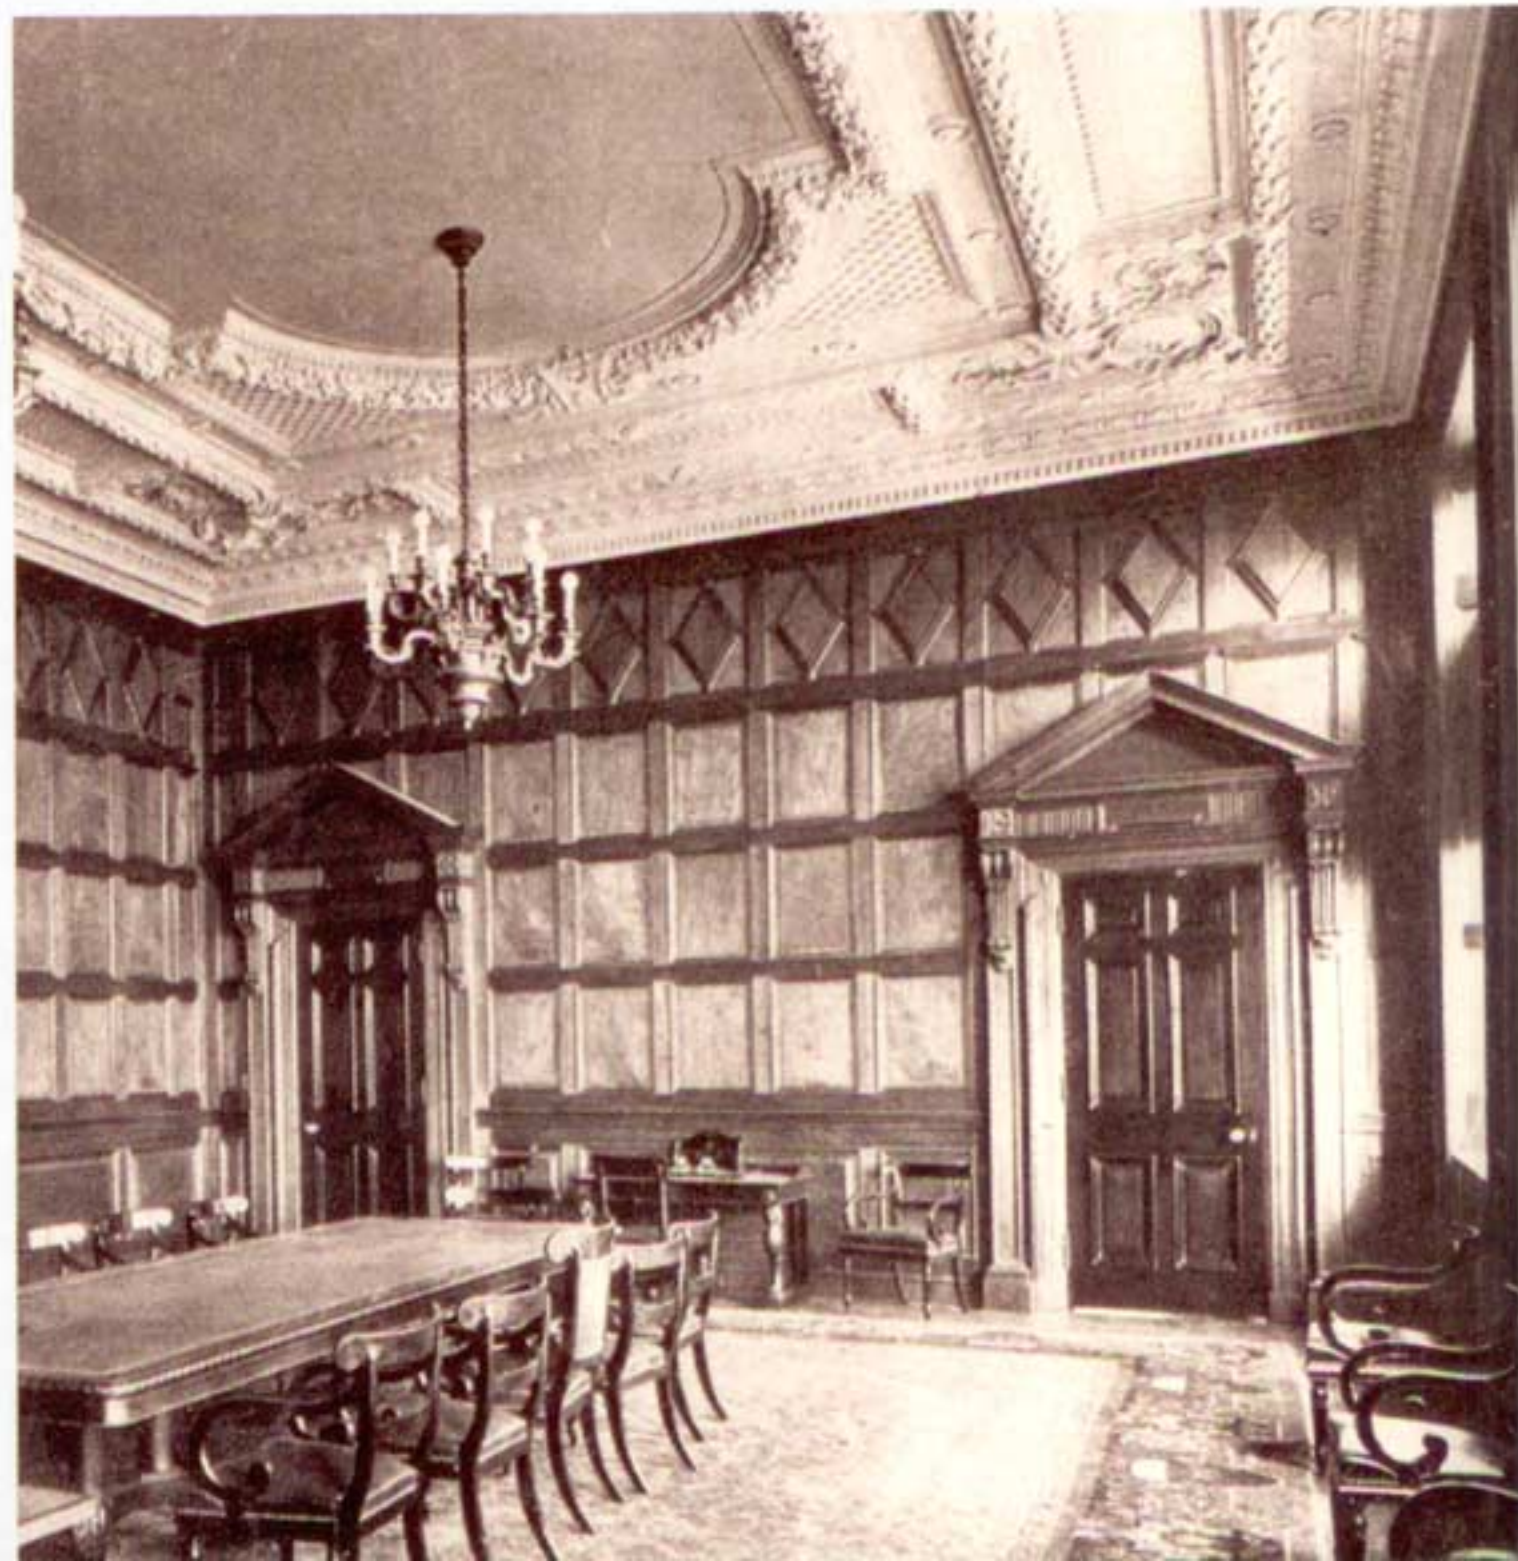
Where plaster molds are required, a self-thickening Thixotropic mold-making process is employed. To make the mold of a ceiling medallion, for example, Iconoplast uses a mould compound called Polygel 40 brushed on about one fifth of the medallion and overlapping onto the ceiling about two inches. This becomes the molding margin or toweeling line for casting the piece, explains Furieri. The compound is re-applied until the piece to be duplicated is covered by 1/4-inch thickness.

Once cured, the compound is then covered with a shell case that covers the urethane and keeps its shape for reproduction. A thin coat of plaster is brushed on the compound, further coats contain a mix of plaster and burlap

until a thickness of 3/8-inch is obtained. He says any thicker than 3/8-inch can jeopardize the stability of the mould.
